HUBBELL®

TIPS & NEWS

Vol. 6 No. 1 JANUARY 2001

Severe Storms Topple Towers

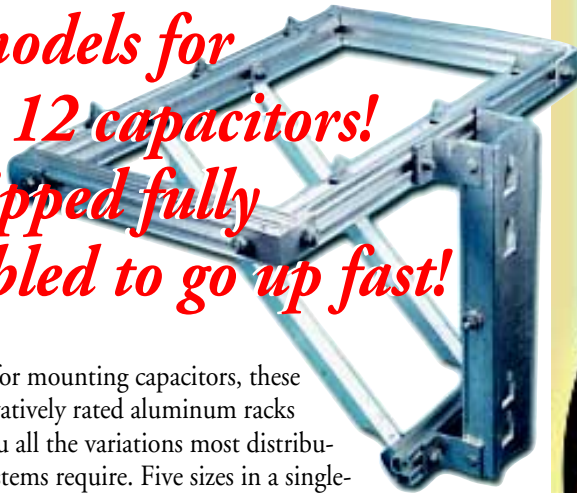
HUBBELL CAPACITOR RACKS

Strictly for mounting capacitors, these conservatively rated aluminum racks give you all the variations most distribution systems require. Five sizes in a single-pole style, accommodate one to twelve 200-kvar capacitors. Even the largest comes fully assembled to save installation time and money.

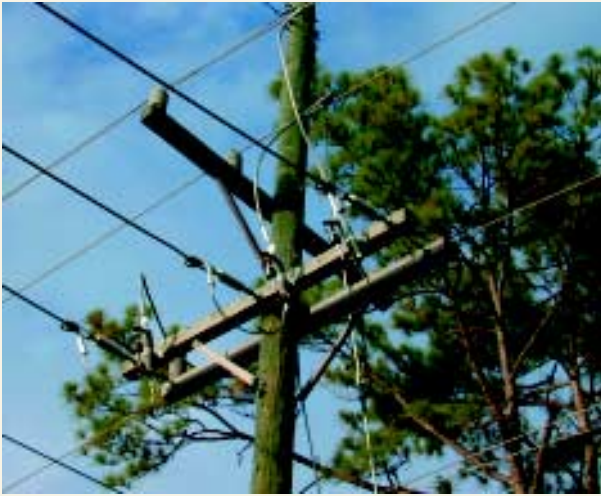
Overhead lateral tap application of Chance Electronic Sectionalizers eliminates nuisance outages.

Three-count Sectionalizers are utilized on our overhead distribution circuits. Typically, our reclosers are set to lockout after four trips. A three-count Sectionalizer provides isolation of the faulted section before locking out the recloser. Faults on a fused lateral tap downline of the recloser and the three-count Sectionalizer can be cleared prior to lockout or opening of the upline devices.

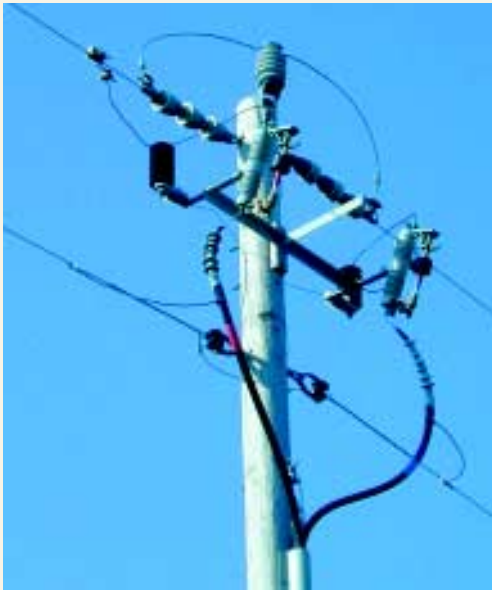
Underground tap application of Chance Electronic Sectionalizers enhances protection coordination and improves utilization of cable ampacity.

One-count Sectionalizers are utilized on our underground lateral taps to eliminate multiple shots of fault current that potentially could damage the cable. ■

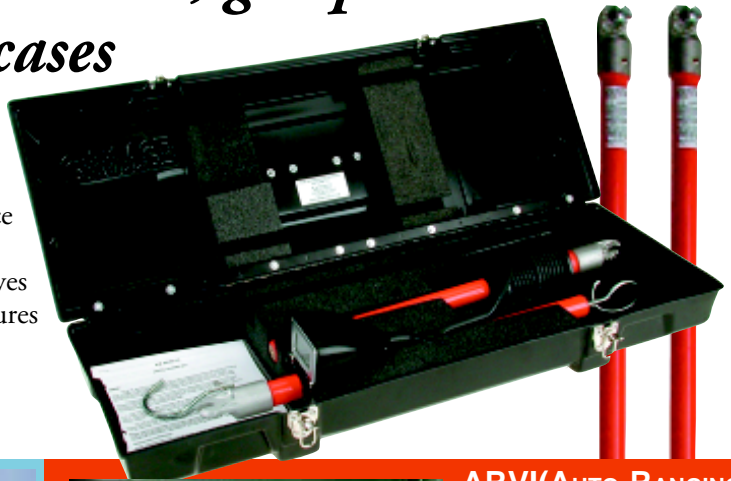
ARVI (AUTO-RANGING VOLTAGE INDICATOR)

A bright red light and audible tone indicate the phase-to-phase voltage class sensed by the ARVI (Cat. No. C403-3374). It automatically begins detecting at 480 Volts and displays one of these voltage classes: 600V, 4kV, 15kV, 25kV, 35kV or 69kV.

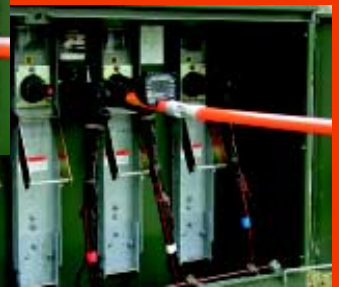
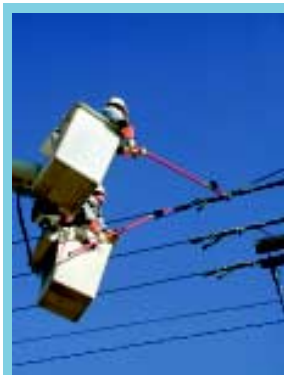
ARVI holds reading for voltage-indication tests on switch bushing (above) and cable (at right, using a feed-thru device).

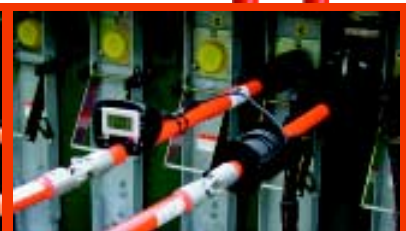
Phasing Tester lets you quickly identify overhead phases and read voltage for Ø-G and Ø-Ø tests.

16kV (C403-3369) and 40kV (C403-3370) Phasing Testers present large direct-reading displays with backlight and hold features and an energy-saving sleep mode.

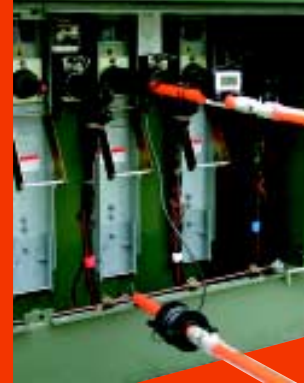
(Above left) Phase-phase voltage test, (above right) hi-pot test of cable with 16kV Kit's DC Hi-Pot Adapter between meter and bushing adapter (feed-thru device not included) and (at left) phase-to-ground test.

To extend duty through 80kV, Extension Resistors (Cat. No. C403-3371) are available as accessories. Use on systems above 40kV requires Universal Poles longer than the 6-ft. poles furnished with each Kit.
